RAILWAY INVESTIGATION REPORT
R00D0098

COLLISION AND DERAILMENT

VIA RAIL CANADA INC.
TRAIN NO. 603
MILE 119.35, LA TUQUE SUBDIVISION
LA TUQUE, QUEBEC
30 AUGUST 2000

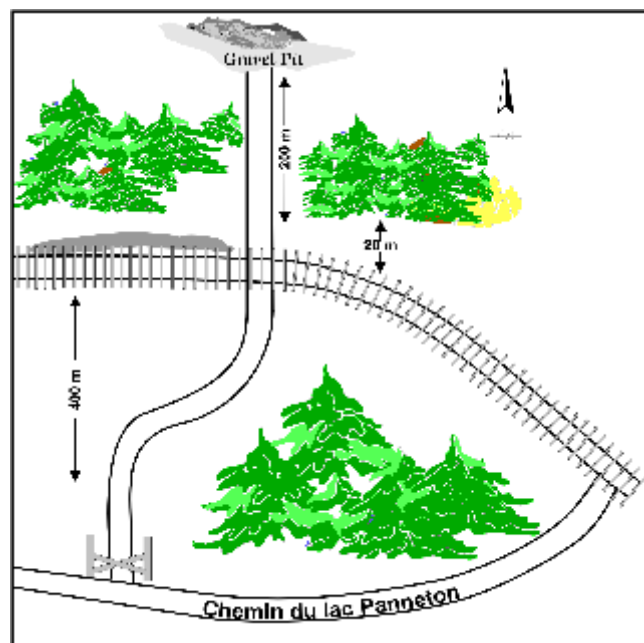
Figure 1—Occurrence site illustration

The road leading to the crossing is a restricted-access private road beginning at the Chemin du lac Panneton and ending at the gravel pit. It is a narrow winding road that runs for approximately 400 m before crossing the railway track (see Figure 1). On the north side of the track, the road is tangent with a descending grade followed by an ascending grade as far as the gravel pit. The land adjacent to the road is wooded to about 20 m from the railway track. Given the characteristics of the road, the loaded trucks travel at a speed of approximately 7 km/h; at that speed, a truck takes 11 seconds to travel the distance between the end of the woods and the crossing. Based on the number of trips made by the gravel trucks, the road traffic passing over this crossing is estimated at more than 80 heavy vehicles per day.

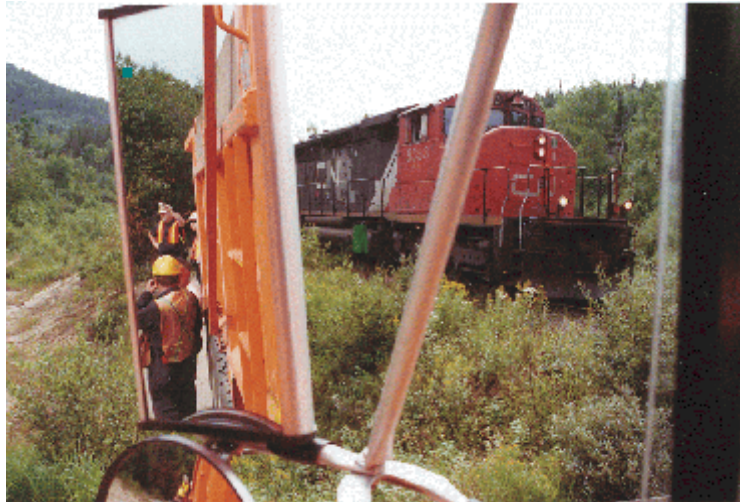
Figure 2—Visibility from a truck 8 m from the crossing

A simulation was conducted at the crossing on 01 September 2000. A truck of the same size but of a different model from the one involved in the collision was used. The dimensions and position of the exterior mirrors relative to the driver were similar. The simulation revealed that the left rearview mirror blocked the driver's view to the east (see Figure 2) when the truck was 8 m from the track (the distance specified in the TC sight-line guidelines); in these conditions, a freight train could be perceived only when it was 14 m from the crossing.

1. The truck driver's left rearview mirror created a blind spot that obstructed a large part of the field of view and may have prevented the driver from seeing the train approaching.
2. A quality control program ensuring compliance with established standards would provide an additional mechanism to ensure that some anomalies potentially having an impact on the safety of railway employees and the public are identified and corrected.
3. Reassessment of the risks based on the specific features of each crossing may prove necessary, because some crossings, even private crossings, have substantial seasonal traffic fluctuations that may affect safety.
